Information Circular 9072

Ground Subsidence and Structural Damage Over an Abandoned Room-and-Pillar Coal Mine at Hegeler, IL

By Gennaro G. Marino, James W. Mahar, Larry R. Powell, and Richard E. Thill

BUREAU OF MINES
Robert C. Horton, Director

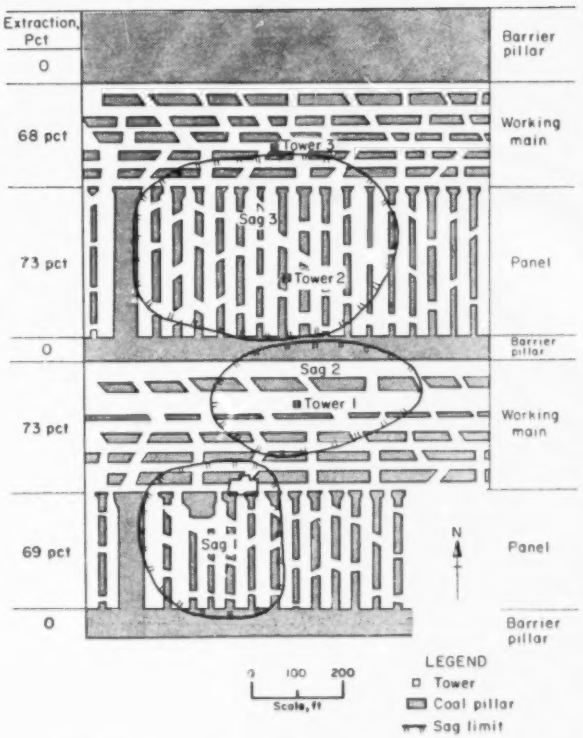
FIGURE 4. - Mine map showing location of subsidence sags.

Three subsidence sags have developed in the study area between 1967 and 1978. The locations of the sags occurred above areas of high extraction (fig. 4). Subsidence has progressed northward starting with sag 1 in 1967, sag 2 in 1968, and sag 3 between 1976 and 1978. The sags range from 240 to 570 ft in diameter. Sag 1 encompasses the radio station building and an area to the south and west. Sags 2 and 3 developed north of the building in the field containing the transmission towers. Sags 1 and 2 subsided with one main event, but sag 3 developed in two or more major events in which the ground movements have progressed westward. A summary of the subsidence history at the study site can be found in the appendix.

Sag 1 started to develop in the vicinity of the radio station about noon on July 21, 1967. The subsidence eventually encompassed the access road and parking lot and the surrounding area. The ground movements damaged three houses, the radio station, and service utilities to these structures (26-29). In addition, the southern guy wires to tower 1 were tensioned. The maximum settlement (about 3.5 ft) occurred over an area west of the radio station parking lot and access road. Although most of the displacement occurred within 2 days, ground movements were reported as late as October 1967. Then, in May or June 1969, the northern portion of the radio station building sustained additional damage from residual movements in the northern portion of sag 1.

Sag 2 develop in the field north of the radio station building in May or June 1968. The center of the sag is located 40 ft northwest of tower 1. Most of the settlement (3 ft) occurred rapidly within 6 weeks. Tower 1 subsided 2.75 ft, which caused the guy wires supporting the tower to loosen, and they had to be retightened several times. Surface water collected in the sag around tower 1.

In November or December 1976, sag 3 developed under tower 2. The tower nearly failed when it settled and tilted 0.05 ft to the east. In July 1978, residual subsidence of sag 3 produced settlement and lateral movement of the southwest guy wire anchors for tower 3. The upper 150 ft of the tower was bent in response to the ground movements. The maximum settlement was about 3 ft.

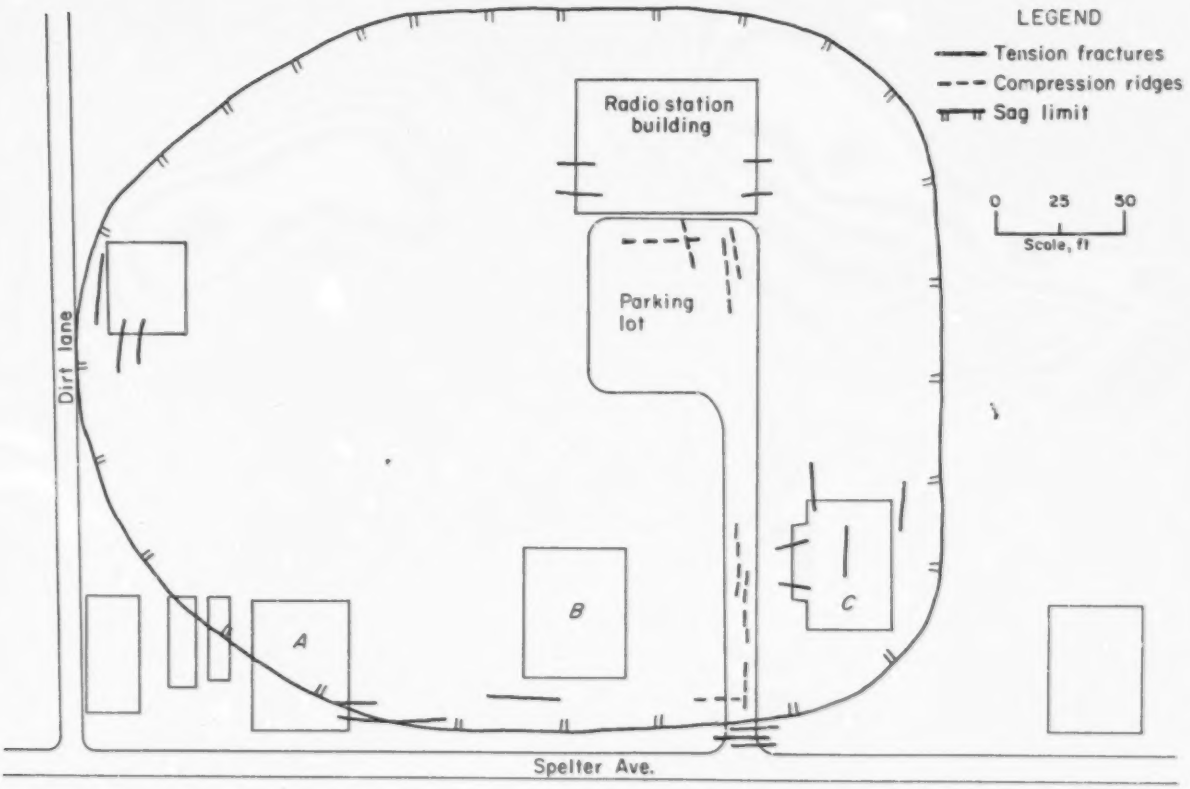
FIGURE 6. - Sketch map of sag 1 tension and compression features in 1967.
(Courtesy of Illinois State Geological Survey.)

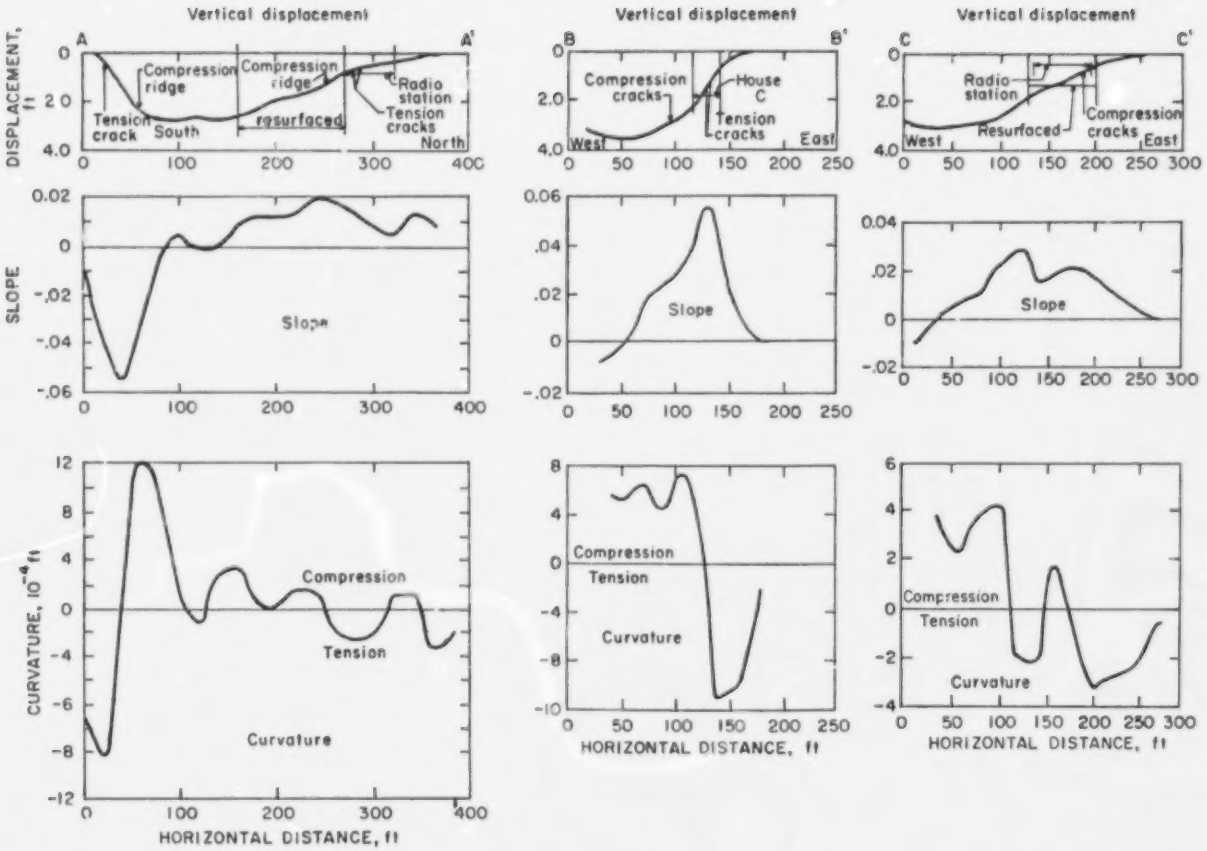
FIGURE 8. - Adjusted profiles, slopes, and curvatures for sag 1. Profile slopes and curvatures calculated on 40-ft lengths from survey data. Surveyed Nov. 11, 1978.

Sag 1 is a 290- by 350-ft semirectangular depression with rounded corners. The area of maximum settlement is approximately concentric to sag limits. A maximum settlement of 3.5 ft is located 100 ft west of profile A-A' (fig. 8). The ratio of settlement to extraction height, known as the subsidence factor, is 0.55.

The maximum slope[5] in sag 1 is 0.055 and occurs on the southeast side where house C was located (fig. 8, B-B'). Slopes decrease to the north. Around the radio station building, the maximum slope is roughly 0.02. Both structures are located in the tension zone but on opposite sides of the sag. Curvatures, corresponding to the maximum tension and compression, are 1.2×10^{-3} ft^{-1} on the south side of the sag and 2.0 to 4.0×10^{-4} ft^{-1} on the north side. Figure 11 shows tension cracks and compression ridges associated with sag 1.

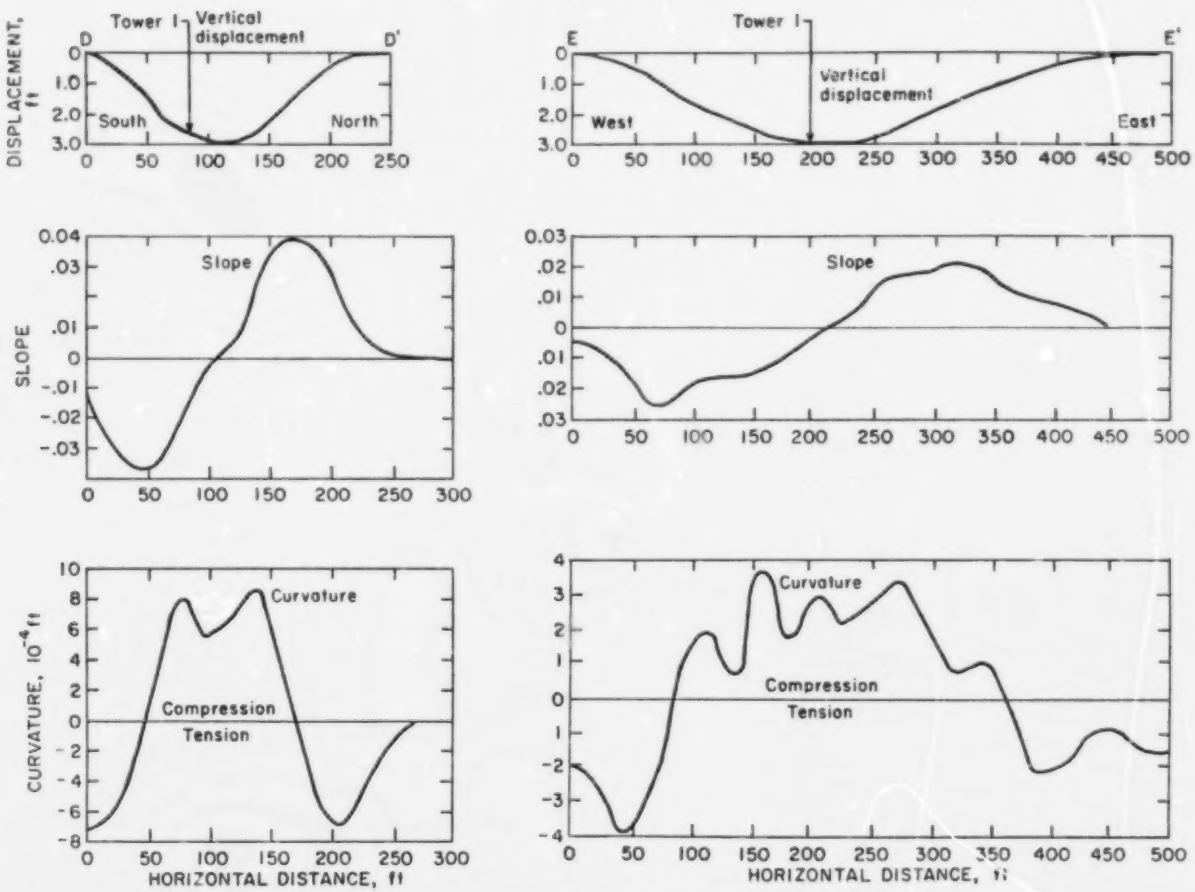
FIGURE 9. - Adjusted profiles, slopes, and curvatures for sag 2. Profile slopes and curvatures calculated on 40-ft lengths from survey data. Surveyed July 9, 1981.

Sag 2 is a 450- by 240-ft elliptical depression elongated in the east-west direction. The sag encompasses the base of tower 1 and most of its guy wire anchors. The adjusted displacement profiles (fig. 9) show the sag to be a bowl-shaped depression with a maximum settlement of about 3 ft.

Slopes for sag 2 are greatest along the north-south profile (fig. 9, D-D') where the maximum slope is 0.038. This value is 1.5 times greater than the maximum slope in the east-west direction. The maximum curvatures are 8.6×10^{-4} ft^{-1} in the compression zone and 7.0×10^{-4} ft^{-1} in the tension zone. Both occur along the north-south profile and are about twice those in the east and west portions of the sag.

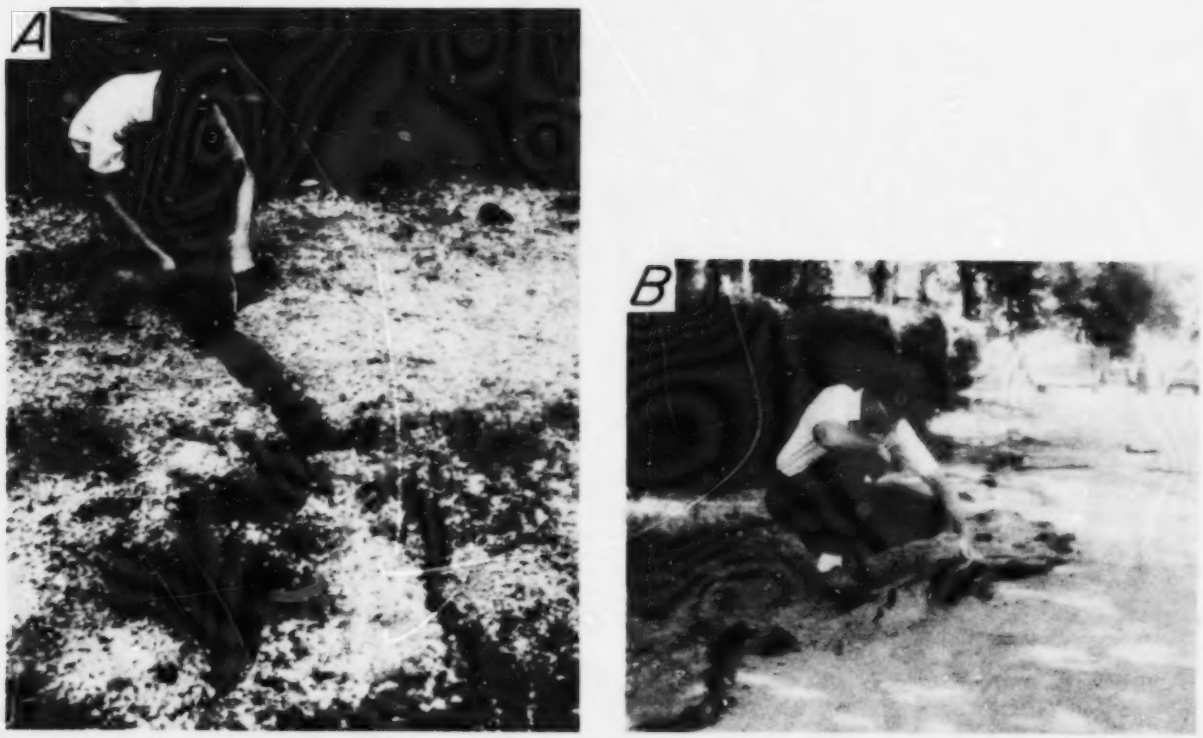
FIGURE 11. - Photographs of 0.33-ft-wide tension cracks (*A*) and 0.25-ft-high compression ridges (*B*) from sag 1 on June 24, 1967. *(Courtesy of Illinois State Geological Survey.)*

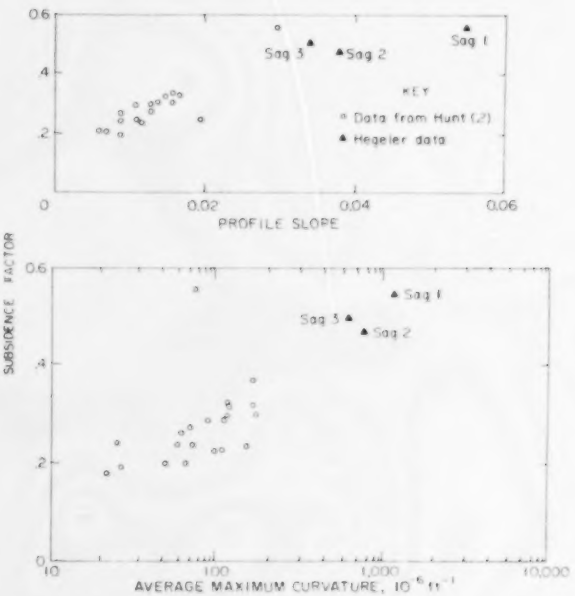
FIGURE 13. - Relationship between the subsidence factor and (*A*) profile slope and (*B*) average maximum curvature.

In general, the maximum slopes and curvatures of subsidence sags tend to increase with increasing subsidence factors. These relationships are shown by Hunt (2) for subsidence profiles in Illinois. The sags at the Hegeler site, however, are more severe than those studied by Hunt (fig. 13).

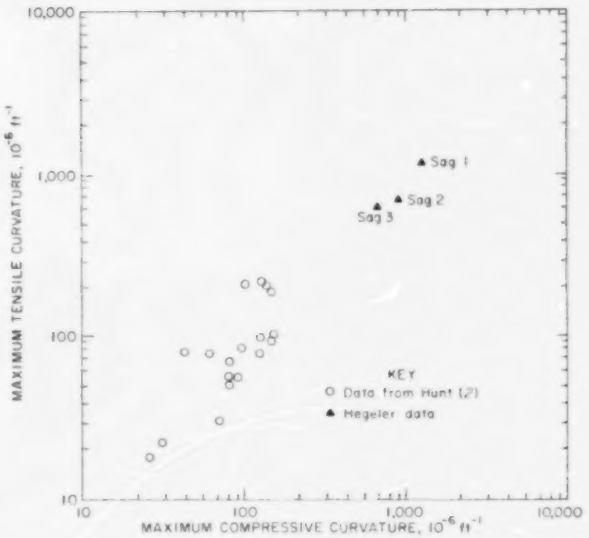
FIGURE 14. - Relationship between maximum tensile curvature and compressive curvature.

Figure 14 shows that maximum tension and compression are almost equal in cases of Illinois mine subsidence above abandoned room-and-pillar mines. However, when compared with data from other Illinois mines, the Hegeler sags are much more severe.

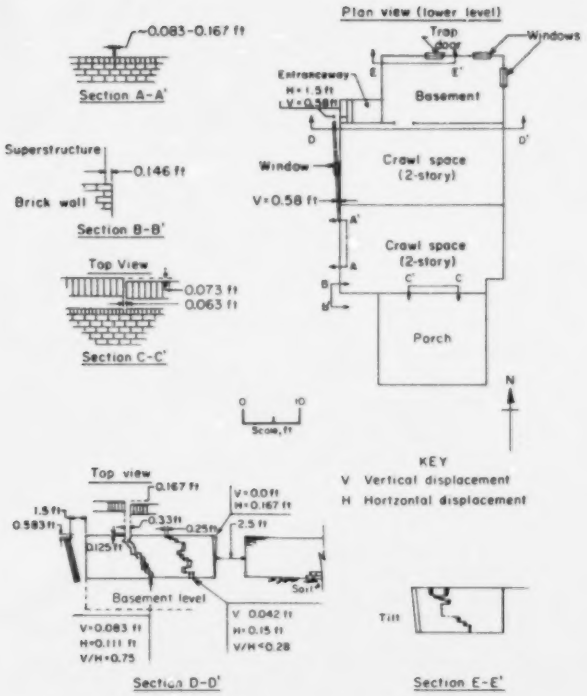
FIGURE 15. - Plan of damage to house C. The damage was measured in May 1978. (Sections shown are not to scale.)

The bearing walls and on-grade members cracked, separated, and tilted in response to the ground movements. Cracks opened as much as 0.33 ft, and walls separated as much as 1.5 ft. The west brick wall of the crawl space tilted, settled, and moved laterally away from the superstructure (fig. 15, sec. D-D'). At the north end, it separated horizontally 1.5 ft and vertically 0.58 ft from the interior bearing wall. These wall displacements occurred because there was no foundation-superstructure attachment between the exterior and interior walls. The vertical separation prevented the development of frictional resistance between the sill and wall, thus there was essentially no restraint against outward movement. Most of the damage to the west wall was caused by differential rigid body tilt.

The relationship between profile slope and wall tilt is illustrated by the wall separations and crack widths in the northwest corner of the basement (fig. 15, sec. E-E'). Here crack widths and wall separations are two to three times greater at the top than at the bottom. The average tilt of the north and west walls is estimated to be about 0.08. This is comparable to the slope of 0.07 calculated for this section of the sag.

Figure 15, section C-C', shows that the south bearing wall has undergone displacements similar to the north wall. The crack in the south wall has a low vertical-to-horizontal displacement ratio. Measurements of the vertical crack separation on both the north and south walls are consistent with vertical-ground-displacement contours, which decrease in a southerly and westerly direction.

The northward horizontal ground movement caused the superstructure to move north with respect to southern foundation walls. A horizontal offset of 0.15 ft was measured between the superstructure and the west end of the south bearing wall (fig. 15, sec. B-B').

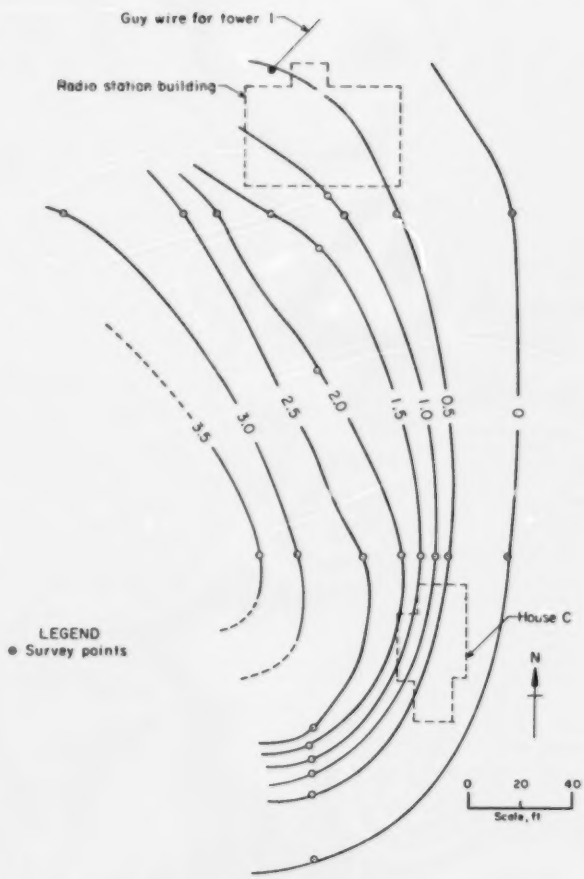
The house was located in the tension zone just inside the southeast corner of sag 1 (fig. 6). Vertical-displacement contours related to sag 1 are shown in figure 16. The ground movements subjected the house to large horizontal strains, angular distortions, rigid body tilt, and translation. Profile B-B' in figure 8

FIGURE 16. - Vertical-displacement contours for sag 1. Survey performed in November 1978.

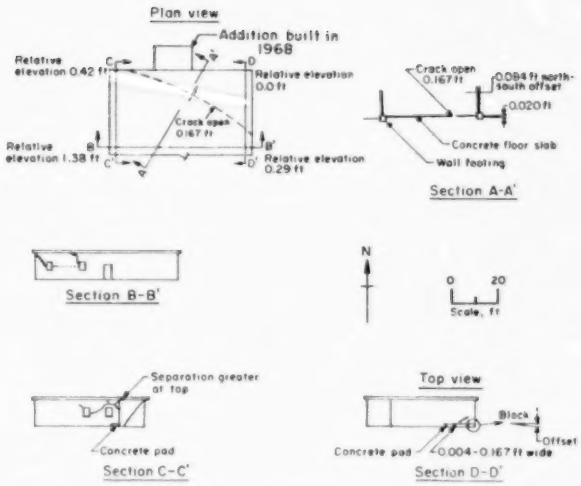
FIGURE 18. - Plan of damage to radio station building. The damage is not inclusive. The relative elevations on the structure were surveyed on July 30, 1967.

The subsidence profiles indicate that settlement across the building ranged from 0.16 to 1.64 ft. A maximum difference in elevation of 1.38 ft was found from the northeast to the southwest corners of the building. The calculated slope between these two corners is 0.02, which is comparable to sag profile slopes of 0.016 and 0.022 (fig. 8, A-A' and C-C'). The maximum tensile curvature through the building is 2.6×10^{-4} ft^{-1} in a north-south direction and 2.8×10^{-4} ft^{-1} in an east-west direction.

The southwestward horizontal ground movements caused cracking and separation of the foundation and floor slab. A vertical crack in the concrete floor opened 0.167 ft and is oriented subparallel to the vertical-displacement contours (fig. 18, sec. A-A'). The superstructure was displaced horizontally along with the southern part of the foundation. On the north wall, the superstructure failed in shear along the mortar joint just above the foundation and was offset 0.083 ft southward relative to the footing. In addition, the southwest corner of the building was offset by the southwest movement of the foundation. The superstructure appears to have been subjected to angular distortion and tension. The torsional deformation was produced by a change in direction and magnitude of ground movements from south to southwest within the building.

About 80 to 90 pct of the damage occurred within 2 days after the initial movement. The damage included jammed doors and windows, a tilted front wall, and cracks in the floor slab, foundation, and exterior masonry block walls. Several months later, the building was remodeled. This work included a false floor, interior repairs, exterior siding, and a brick facade. A permanent shoring system was also installed to support the south wall.

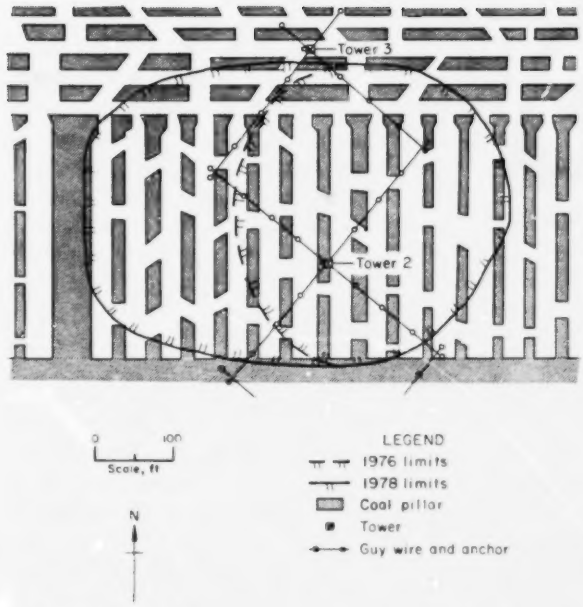
FIGURE 19. - Postulated progression of subsidence associated with sag 3.

In July 1978, additional subsidence occurred, and sag 3 developed in a westerly direction (fig. 19). The renewed subsidence caused additional settlement of the tower 2 base. The cumulative settlement of the tower 2 base is 2.5 ft. The additional movements in sag 3 produced tightening of tower 2 and 3 guy wires. The upper 150 ft of tower 3 was bent as a result of the southwest pull of the guy wire anchor blocks. Guy wires to both towers were retensioned.
